**EVALUATION OF CONCRETE GRINDING RESIDUE (CGR) SLURRY  
APPLICATION ON VEGETATION AND SOIL RESPONSES ALONG NEBRASKA  
STATE HWY 31**

FINAL REPORT

PREPARED FOR THE NEBRASKA DEPARTMENT OF ROADS (NDOR)

(PROJECT #SPR-P1(13)M335)

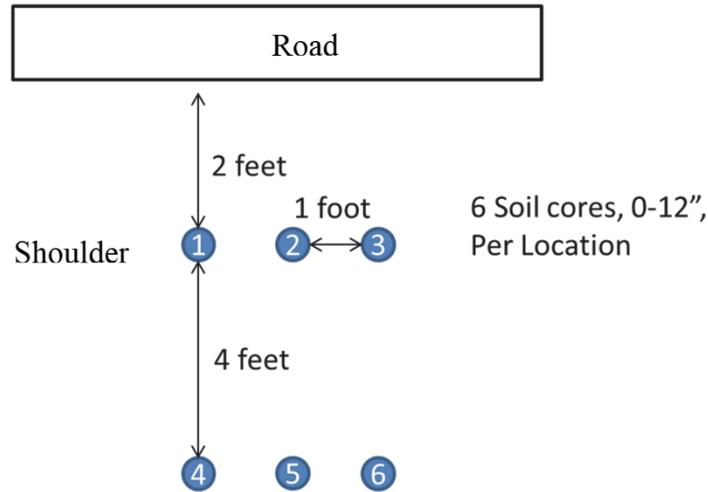
**Figure 2.1** Layout of soil sampling strategy at each sampling point on U.S. HWY 75 and NE State HWY 92

Six soil cores (0-12" depth) were collected at each of 14 sampling points for a total of 84 samples (**Figure 2.1**). The sampling points were georeferenced. At each sampling point 3 cores (cores 1 to 3) were taken near the road (2 feet off the paved shoulder) and 3 cores (cores 4 to 6) were taken close to the ditch (6 feet off the paved shoulder).

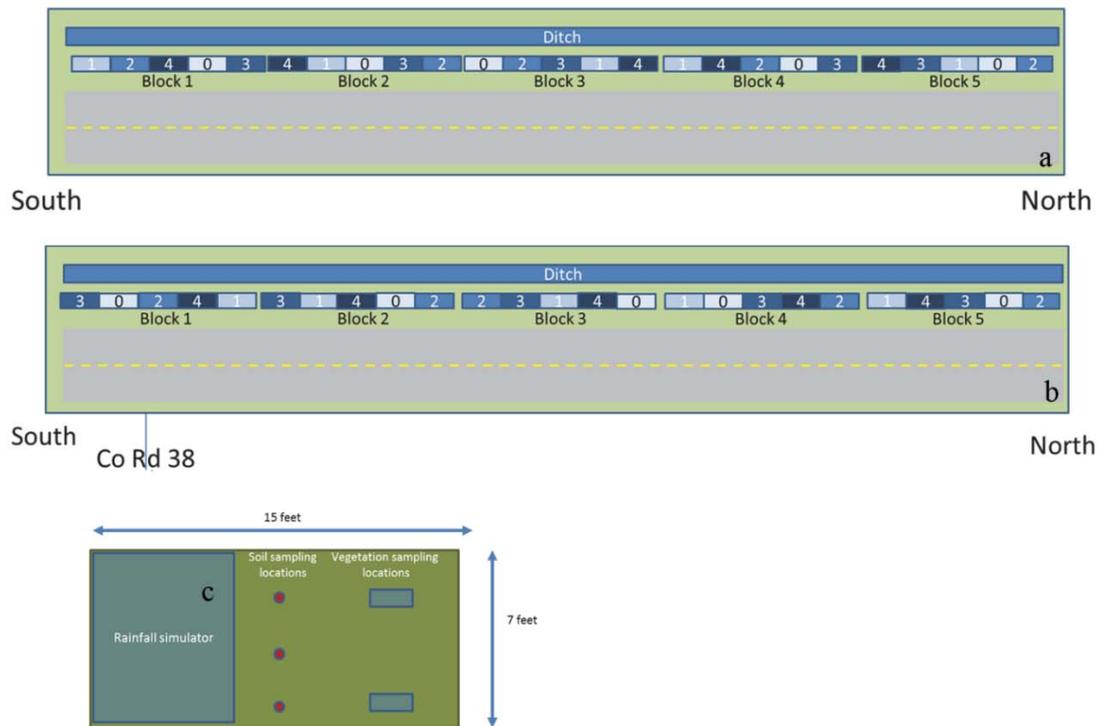
**Figure 2.2** Experimental sites layout on NE State HWY 31 for 2013 at MM36 (a), 2014 at MM34 (b) and plot size and sampling locations within a block (c)

At each site, the field experiment consisted of 5 blocks with 5 treatments (0, 10, 15, 20, 40 dry tons slurry/ acre) per block. Application of treatments at the MM36 site occurred on 18 July 2013 (blocks 3, 4 and 5) and 22 July 2013 (blocks 1 and 2) 2013. Application of treatments at the MM34 site occurred on 6 June 2014. Blocks were laid out from south to north with treatments (0, 5, 10, 20 and 40 dry tons/acre, for treatment numbers 0, 1, 2, 3 and 4, respectively) randomly assigned to the plots within the block (**Figure 2.2**).

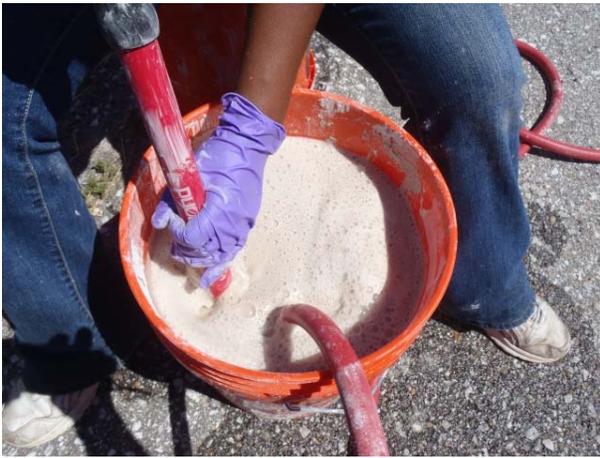
**Figure 2.3 Rewetting and mixing the slurry**

At both sites, the dried slurry was weighed into 5 gallon plastic buckets. Tap water was added on site to each bucket. The slurry was mixed to ensure complete wetness and more water was added to each bucket as needed to achieve a density of 10.5 lb gal<sup>-1</sup>. To ensure uniform application coverage of the plot area, the slurry was applied by hand at the appropriate rate using small plastic pitchers (**Figures 2.3 to 2.6**). **Figures 2.3 and 2.4** are from the application of treatments on 18 July 2013 at MM36 site, and **Figures 2.5 and 2.6** are from the application of treatments on 6 June 2014 at MM34 site.

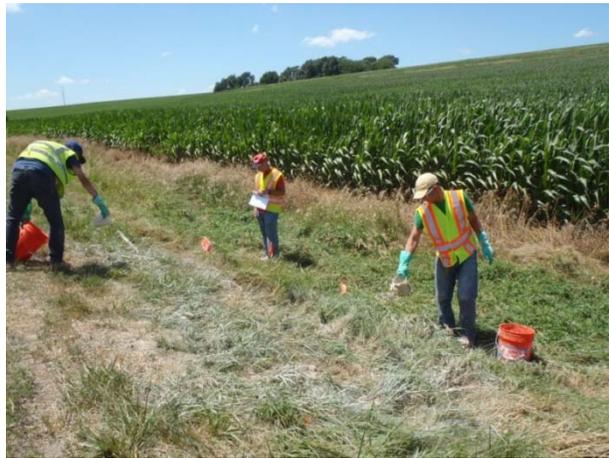
**Figure 2.4 Application of slurry to plots**

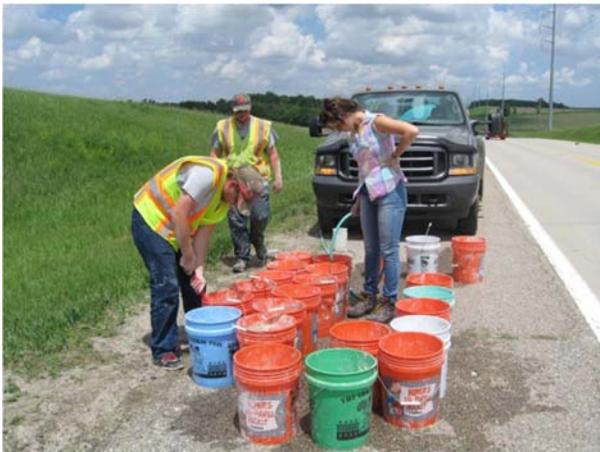
**Figure 2.5 Rewetting and mixing the slurry**

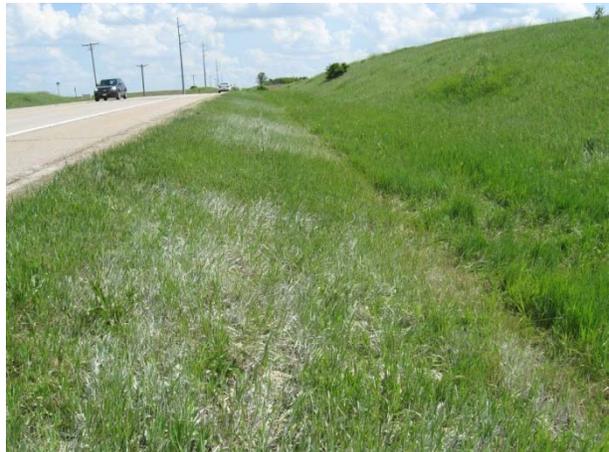
**Figure 2.6 Side view of the plots after slurry**

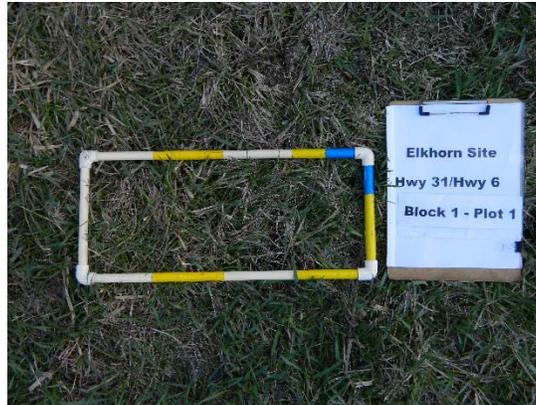
Botanical composition and ground cover assessments were conducted at both sites on all plots using a quadrat method (Daubenmire 1953; **Figure 2.7**) before, one month after and one year after slurry application. At each time, botanical composition and groundcover were measured on two quadrats per plot except for the one year after at the MM34 site where only one reading was done due to plot disturbance from construction. Ground cover was classified into bare ground, litter, plant base, and slurry cover, while aerial botanical composition of canopy was classified by species.

*Figure 2.7 Daubenmire frame for vegetation assessment*

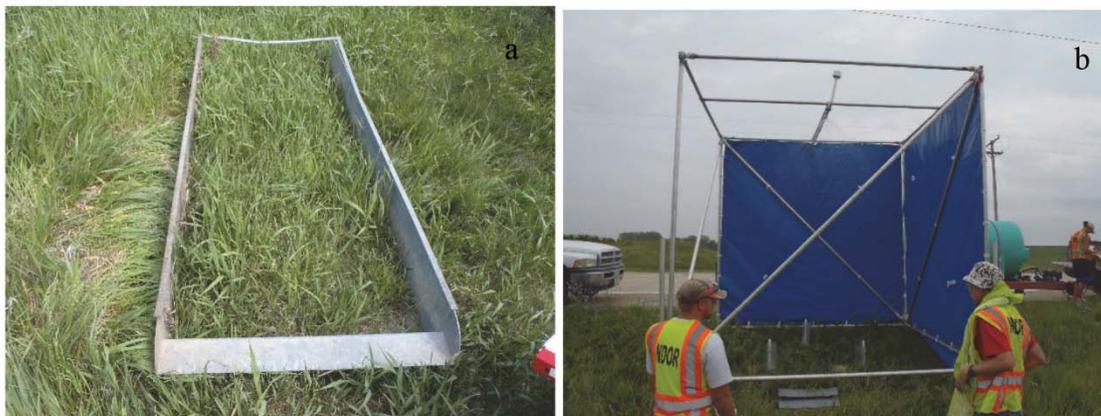
Rainfall simulator, TLALOC 3000 (Joern's Inc. West Lafayette, IN), described in Humphry et al. 2002 was used for the runoff simulation. A 3.3 ft by 1.6 ft steel frame made by the UNL-Tractor Test Lab was used for collection of runoff under the simulator (**Figure 2.8**).

*Figure 2.8 Steel frame, 3.3 ft by 1.6 ft (a) and setup (b) used for rainfall runoff collection*

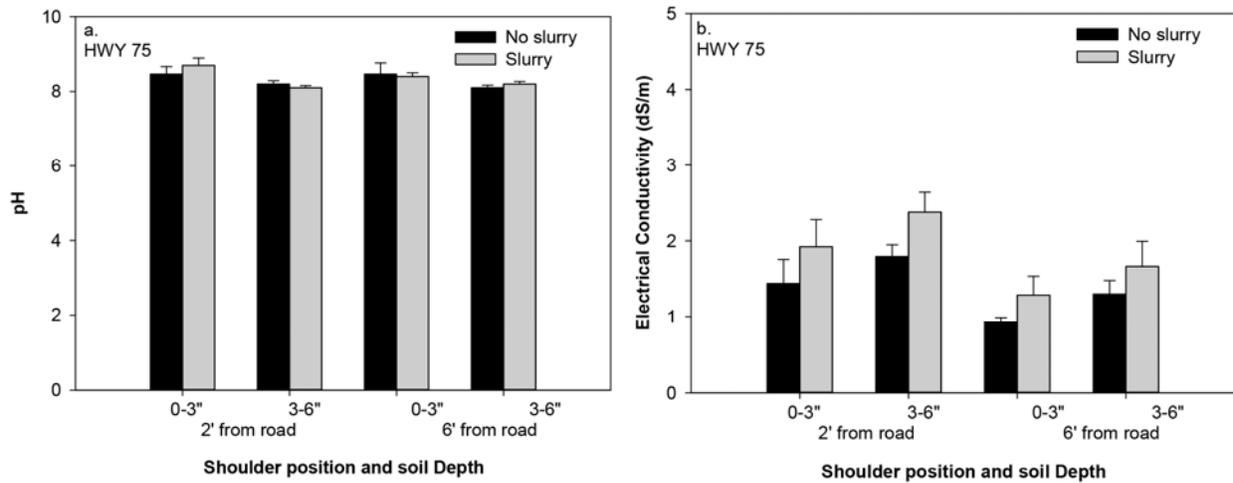
Near road (2 feet from road) pH was higher where slurry was applied, however, 6 feet from the road (near ditch), pH was higher in soil without slurry history.

The pH values for these shoulder soils were around 8.0 while EC values were well below 4 dS/m, suggesting no limitations for plant growth (Waskom et al. 2014). After 1.5 and 2 years of application of CGR to the shoulder soils there was no clear trend on soil pH and EC values. We speculate these soils may buffer the concentration of salts and solutes present in the CGR slurry.

**Figure 3.1** Soil pH (a) and EC (b) at U.S. HWY 75 North of Auburn, NE, for sites with and without application of slurry

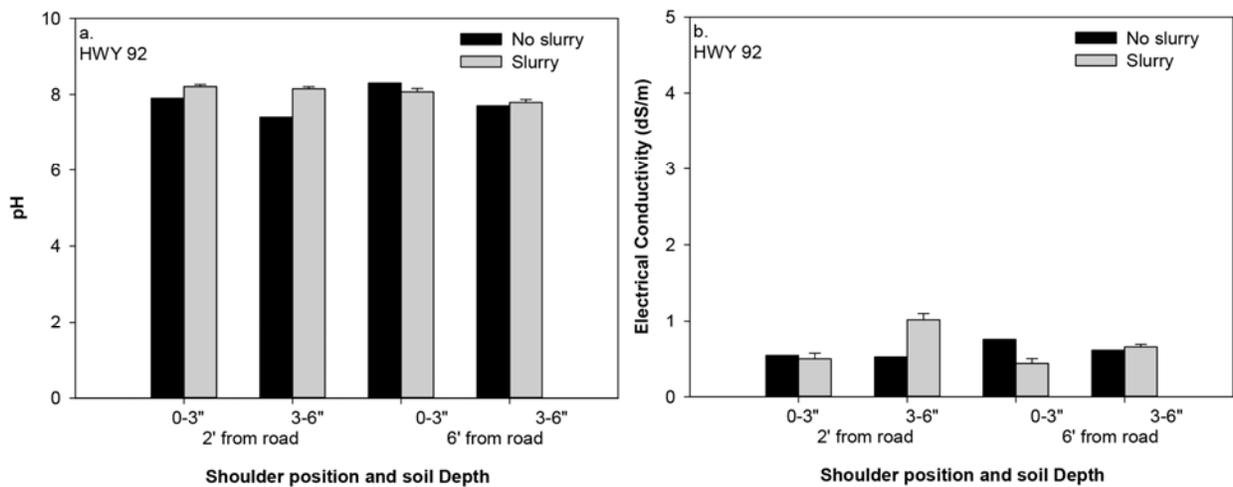
**Figure 3.2** Soil pH (a) and EC (b) in NE State HWY 92 east of U.S. HWY 81, NE, for sites with and without application of slurry

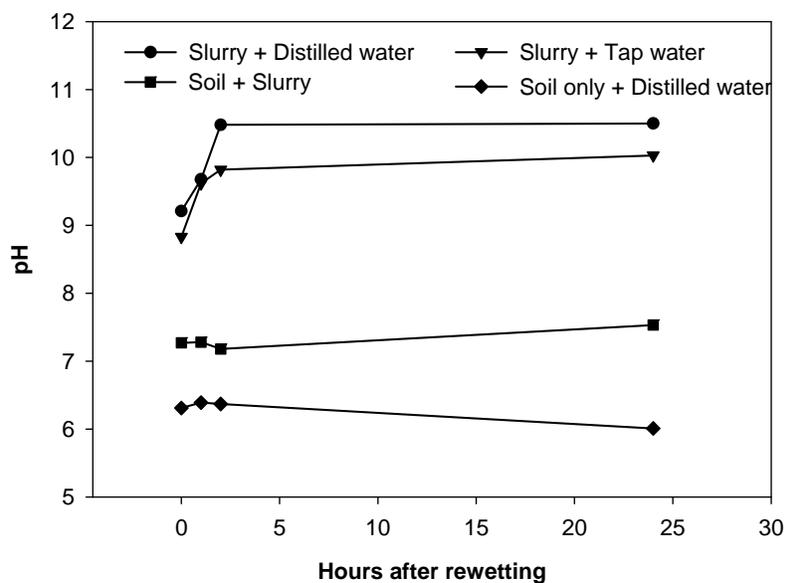
Changes in pH after mixing dried slurry with water or soil were measured over 24 hour period. The pH slurry-water mixture increased from initial rewetting of pH 9 to pH 10 two hours after rewetting. There was an increase in pH of 1 unit after mixing soil and slurry compared to the original soil pH (**Figure 3.3**).

*Figure 3.3 Changes in pH of rewetted slurry and soil after addition of slurry*

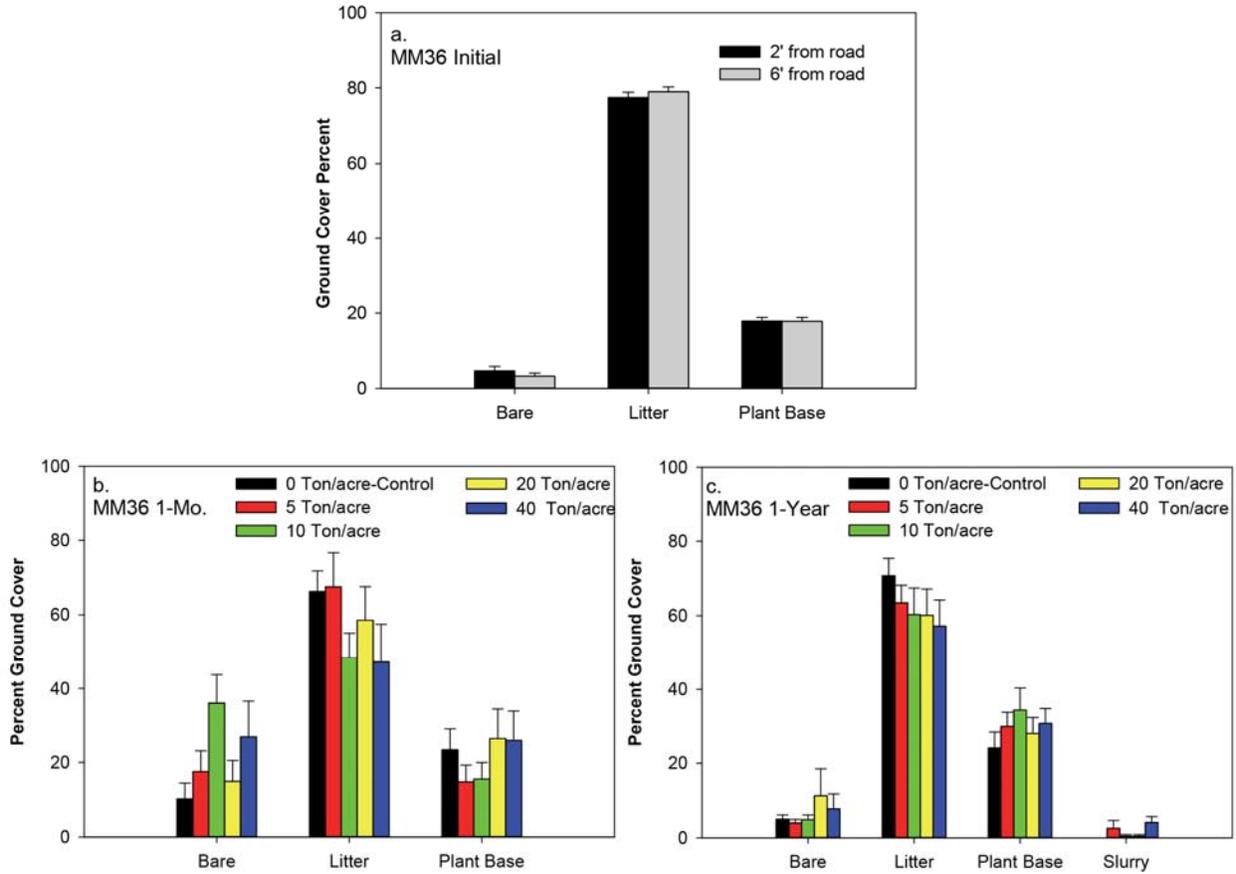
**Figure 3.4** Ground cover of plots on NE State HWY 31 MM36 site before application of treatments (a), one month after application of treatments (b), and one year after application of treatments (c)

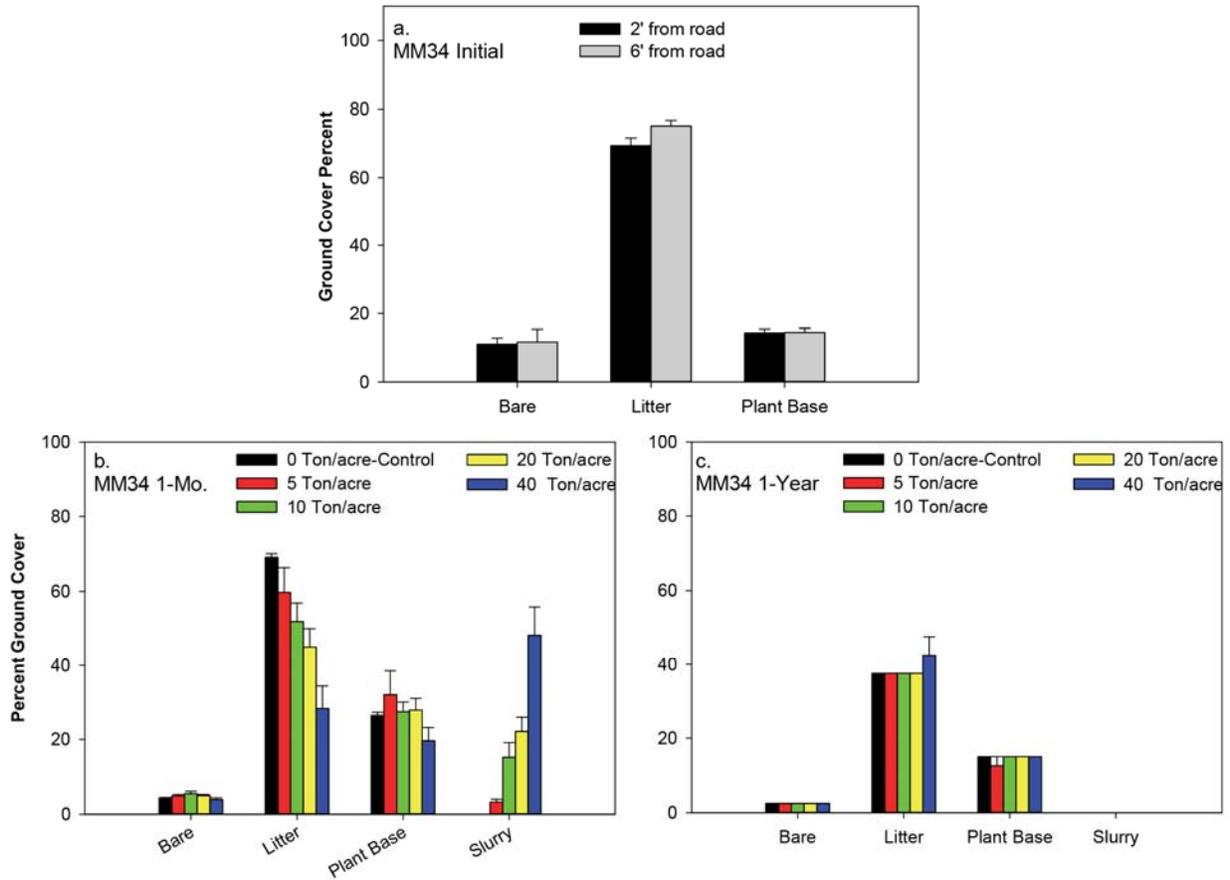
**Figure 3.5** Ground cover of plots on NE State HWY 31 MM34 site before application of treatments (a), one month after application of treatments (b), and one year after application of treatments (c)

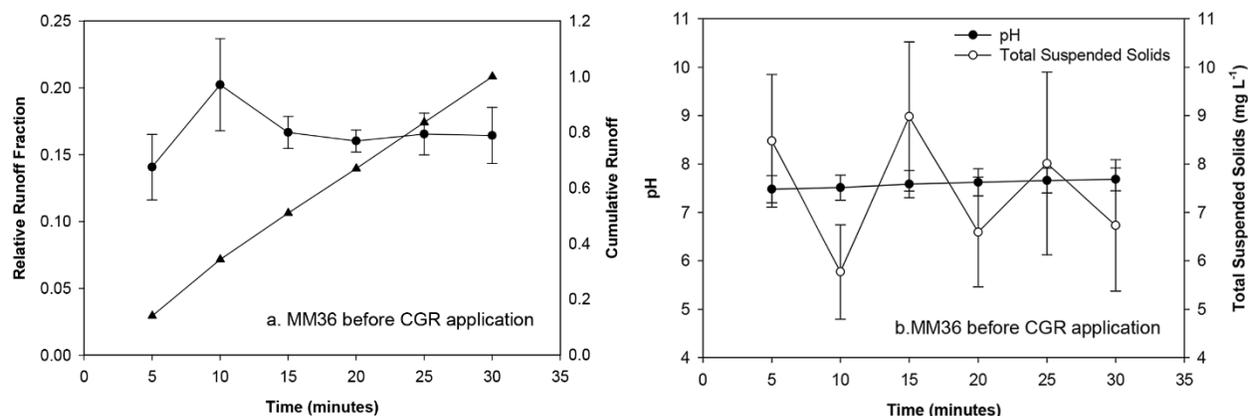
Runoff before application of treatments was conducted at Elkhorn site on 10 and 15 July 2013 on the control treatment (0 tons/acre) plots of each block then on 15 August 2013 for one month after CGR application. The simulated rainfall intensity (average over all five blocks) was 2.1 in/hr and 2.9 in/hr (equivalent to a 10-year storm for the area) for rainfall simulation before and after CGR application, respectively (**Table 3.12**). Soil moisture, by mass, in the first 2 inches was low and below 15% at time of initial simulation and 20% at the time of the one month rainfall simulation. Runoff rate peaked in the second 5 min collection period and then stabilized (**Figure 3.6**).

**Figure 3.6 Simulated average rainfall runoff distribution (a) and runoff pH and total suspended solids (b) measured before CGR application (10-15 July 2013) at NE State HWY 31 MM36 site**

For the pre-application simulation, the pH of the runoff water had a tendency to increase slightly from the southern-most block (Block 1- neutral pH) to the northern-most block (Block 5, slightly alkaline pH) (data not shown) with average pH for initial simulation of 7.5. Total suspended solids (TSS) were variable over time. Average total runoff volume, runoff fraction, runoff pH, EC, and TSS were not significantly different among CGR slurry rates (**Table 3.12**).

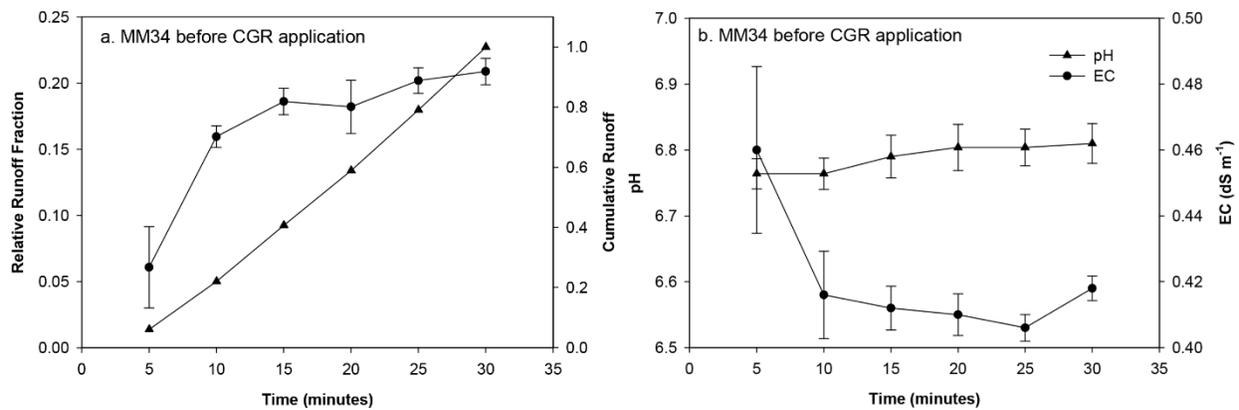
Runoff rate stabilized after the third 5 min collection period (**Figure 3.7a**). Initial runoff pH was less than 7.0 and EC was less than 0.50 dS/m (**Figure 3.7b**).

**Figure 3.7** Simulated rainfall runoff distribution (a) and runoff pH and total suspended solids (b) measured before CGR application (22 May 2014) at NE State HWY 31 MM34 site

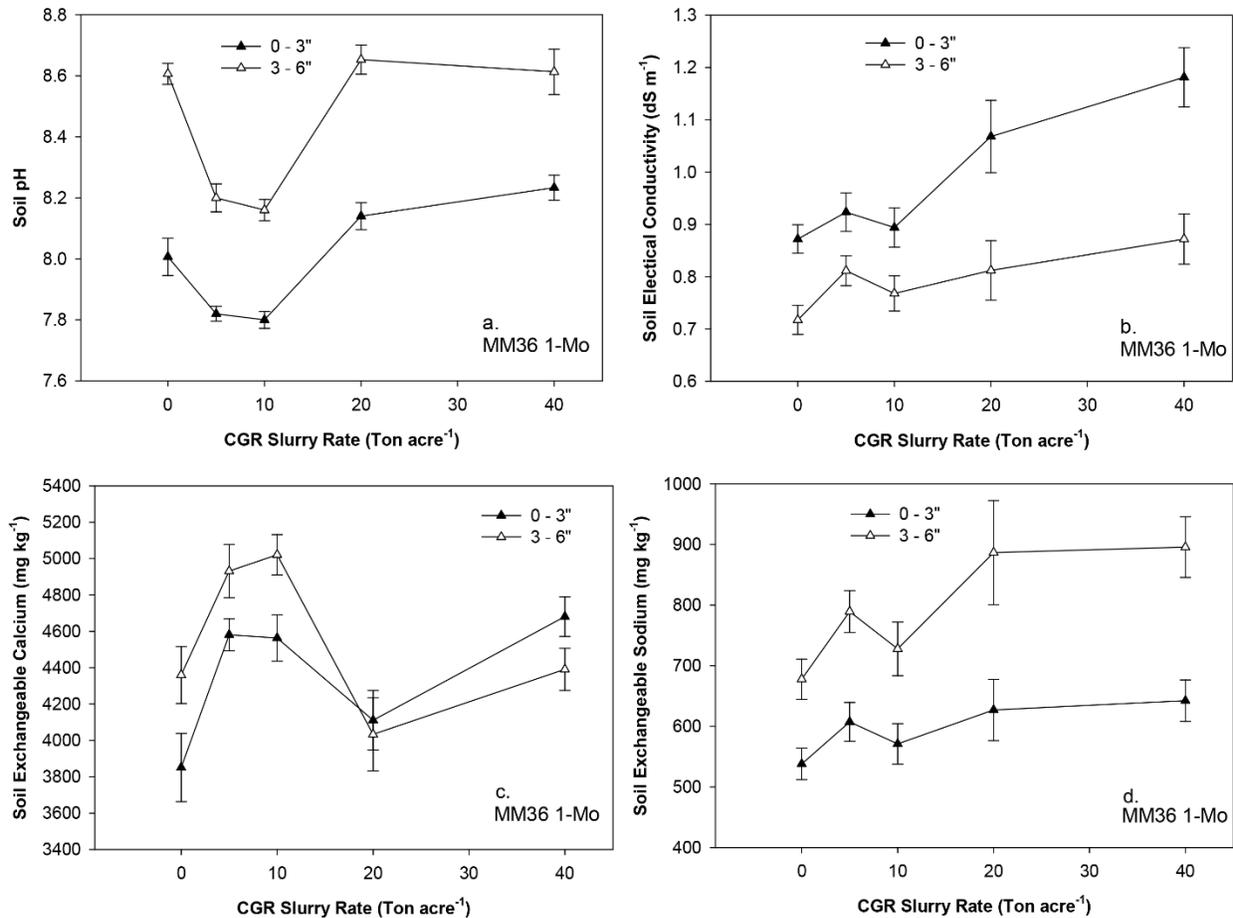
**Figure 3.8** Soil pH (a), soil electrical conductivity (b), soil calcium (c) and soil sodium (d) measured one month after CGR application at NE State HWY 31 MM36 site

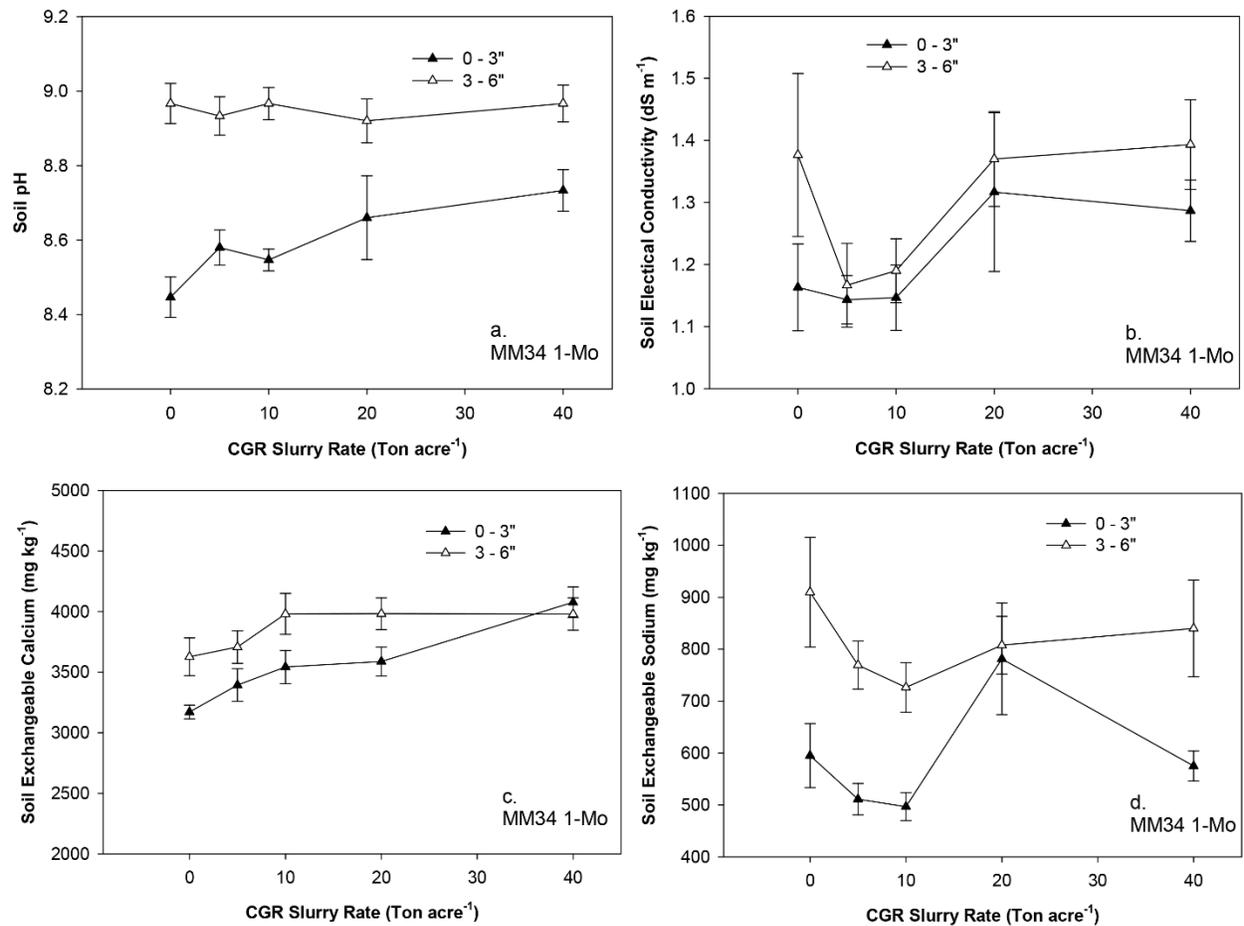
Figure 3.9 Soil pH (a), electrical conductivity (b), soil calcium (c), and soil sodium (d) one month after CGR slurry application at NE State HWY 31 MM34 site
